# Decay Detection Investigation and Climbing Inspection

Oak tree @ 12 Greenways

12 Greenways  
Chelmsford  
Essex  
CM1 4EF

190235-DID-02

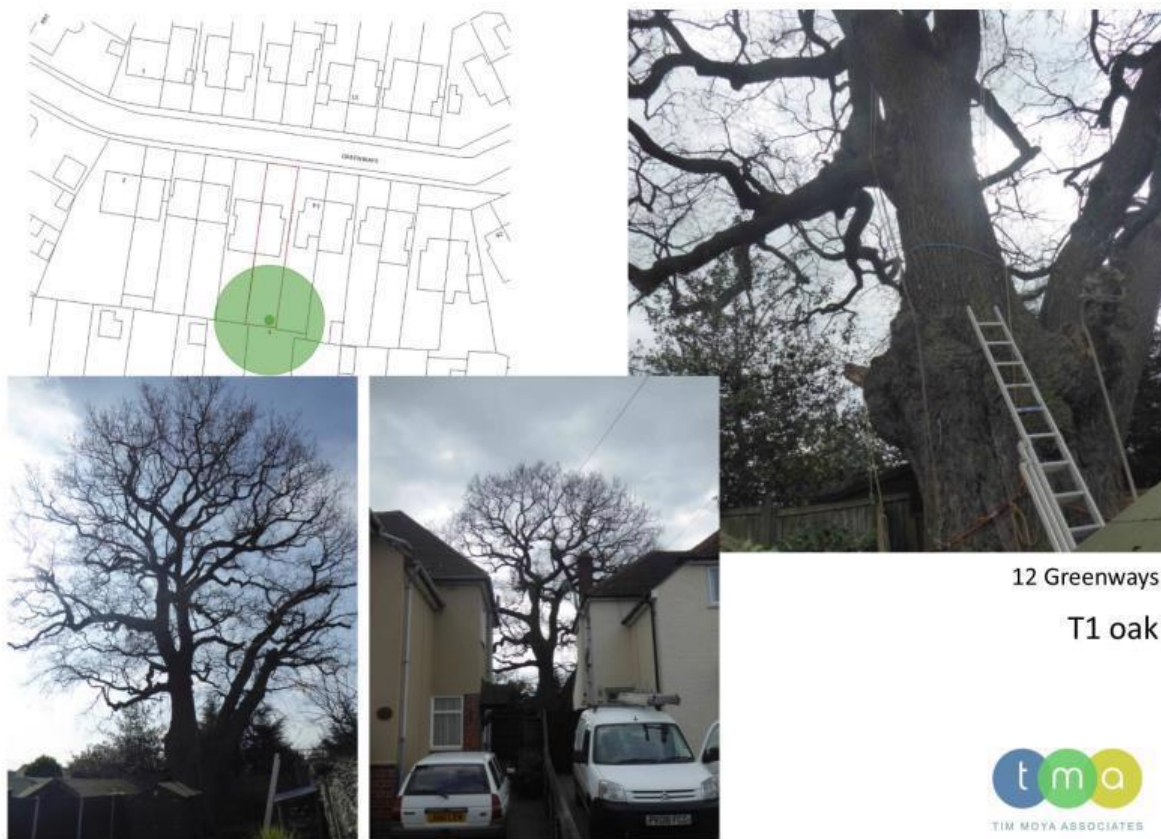
- 3.6 The tree is growing on 'no man's land' situated immediately behind a residential garden, with the crown spreading across six additional residential gardens.
- 3.7 The tree is a large veteran oak, with a very large stem and broad spreading crown. It has been managed in the past with evidence of historic crown reduction and other pruning works having taken place. There is some exposed heartwood and fungal fruiting bodies (*Fistulina hepatica*, decayed and desiccated) around the stem, and a cavity in the crown.

*Oak tree at 12 Greenways: Clockwise from top left, map, accessing the tree, the tree viewed from the street, and from the back garden of the property*

- 3.8 The tree is a large veteran oak with high vitality and good physiological condition. There are numerous pruning wounds and minor deadwood around the crown, which is not unusual in a veteran tree.

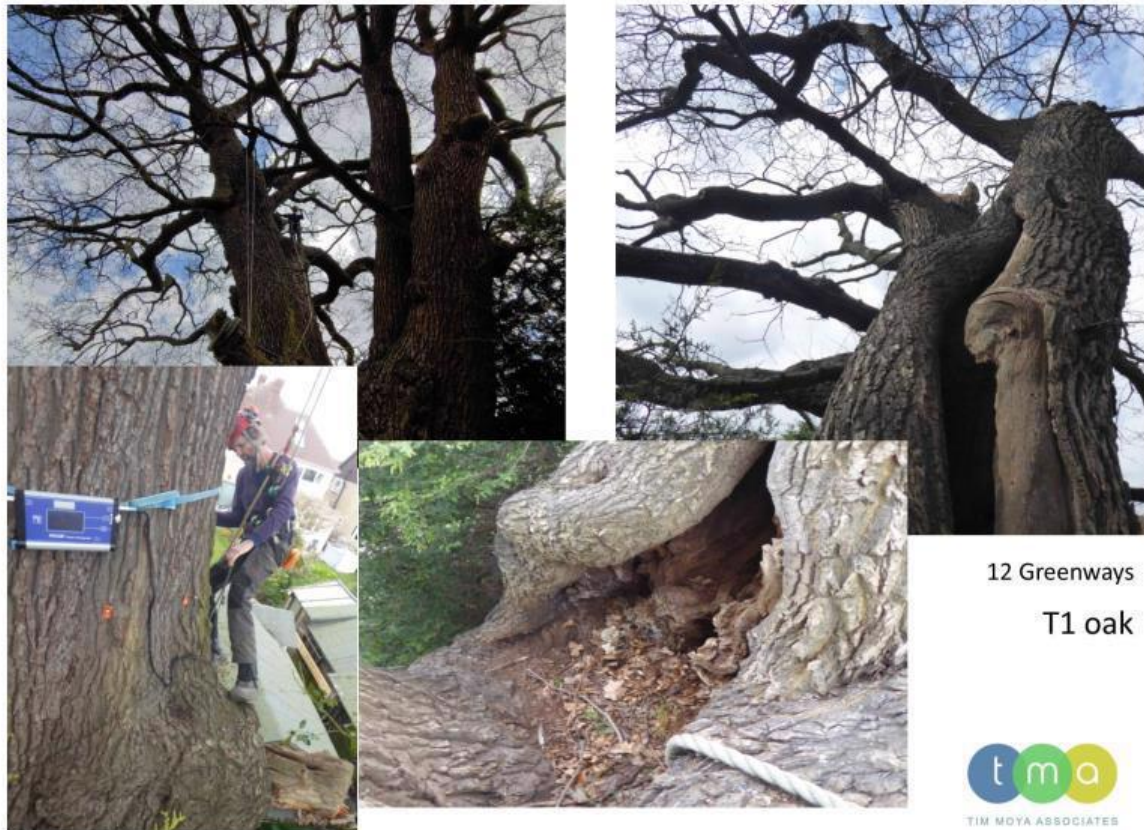
*Climbing inspection of crown: Clockwise from the top left, arborist Jim Curry in the tree, cavity in limb to the west, base of same cavity, Jim Curry undertaking PicUS test @ approximately 5.5m*

- 3.9 3 stems are present above the old pollard head, with the largest stem comprising approximately 80% of the crown and the remaining stems making up approximately 10% each of the crown. A cavity is present in the main trunk which appears to extend from the pollard head down to ground level. It is filled with detritus and an old rope (see above) which had become tightly lodged in the detritus/cavity was dragged out and removed.

- 3.10 There is a cavity on the upper side of the large limb to the west (see above) which extends approximately 5m along the stem. The underside of the leaning stem is intact and an acceptable proportion of sound wood remains. There is minor deadwood present in the mid and upper crown but not widely distributed. No other cracks, breaks, hazard beams or structural weaknesses were observed.

- 3.11 Large apparently healthy buds are present throughout the crown, with an even distribution of growth and viable inner branches present and are indicative of good prospects for the future of the tree following a sympathetic crown reduction. See Appendix A.

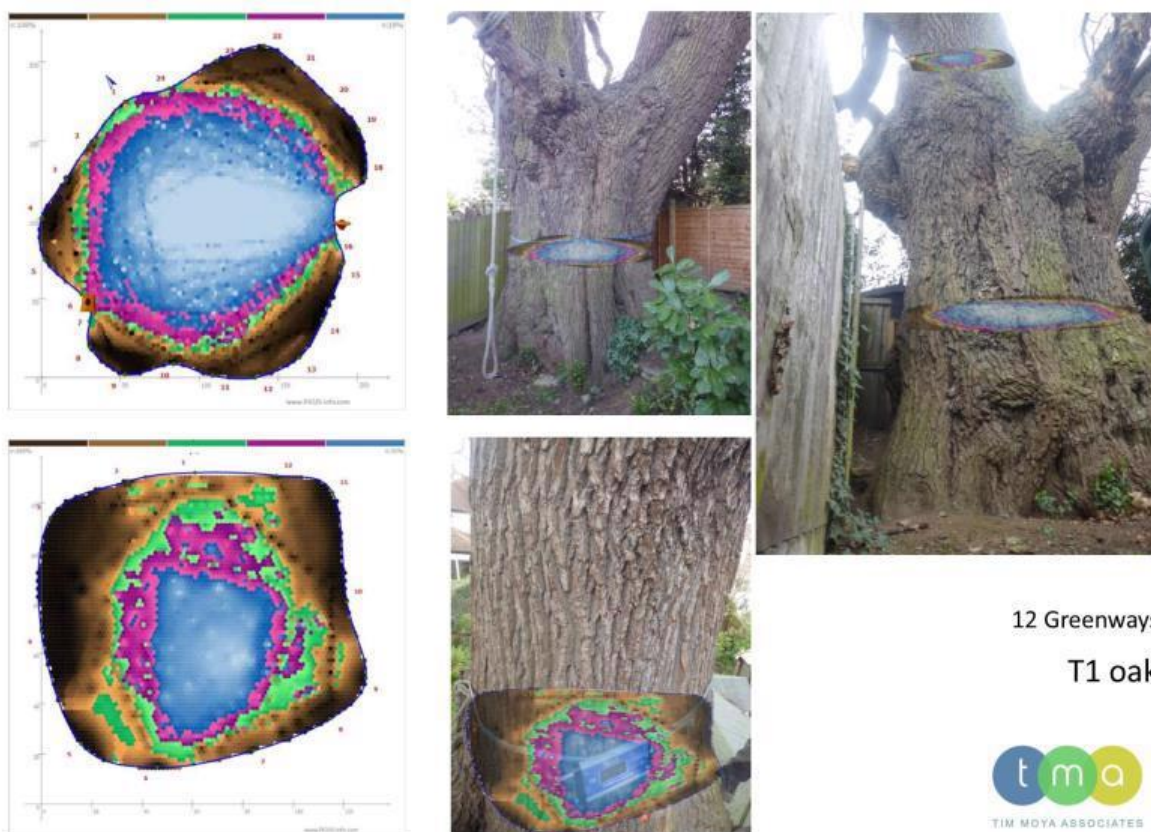
*PiCUS decay detection results: Clockwise from the top left, tomogram @ 1.8m, superimposed in approximate position on the tree, both tomograms superimposed, tomogram @ 5.5m superimposed on the tree and the tomogram @ 5.5m*

- 3.12 The tomogram at 1.8m above ground level (top left) reveals extensive internal decay (light blue, blue, pink) which appears to be well compartmentalised (narrow green, yellow and light brown strips) with a significant proportion of sound wood (dark brown) remaining around much of the circumference at the test height.

- 3.13 The tomogram at 5.5m above ground level (bottom left) reveals considerable internal decay (blue, pink) which is slowly developing (green, yellow, light brown) and a significant proportion of sound wood remaining around the circumference of the stem.

- 3.14 While the decay present in the stem is considerable, the remaining sound wood present in the tree is also very significant and the likelihood of either tree or stem failure is low. As the tree is a veteran, a crown management plan is recommended to minimise the risk of branch failure by reducing weight and wind loading stresses on the tree, with the intention of establishing a smaller crown and prolonging the longevity of the tree.

4.1 The test results indicate that the structural condition of the oak tree is fair. Due to the size of the crown and age of the tree, a management plan is recommended to reduce the crown to a smaller size over a period of years, see Appendix A for details. The tree should be reinspected within 2 years or after storm force events which may weaken its condition.

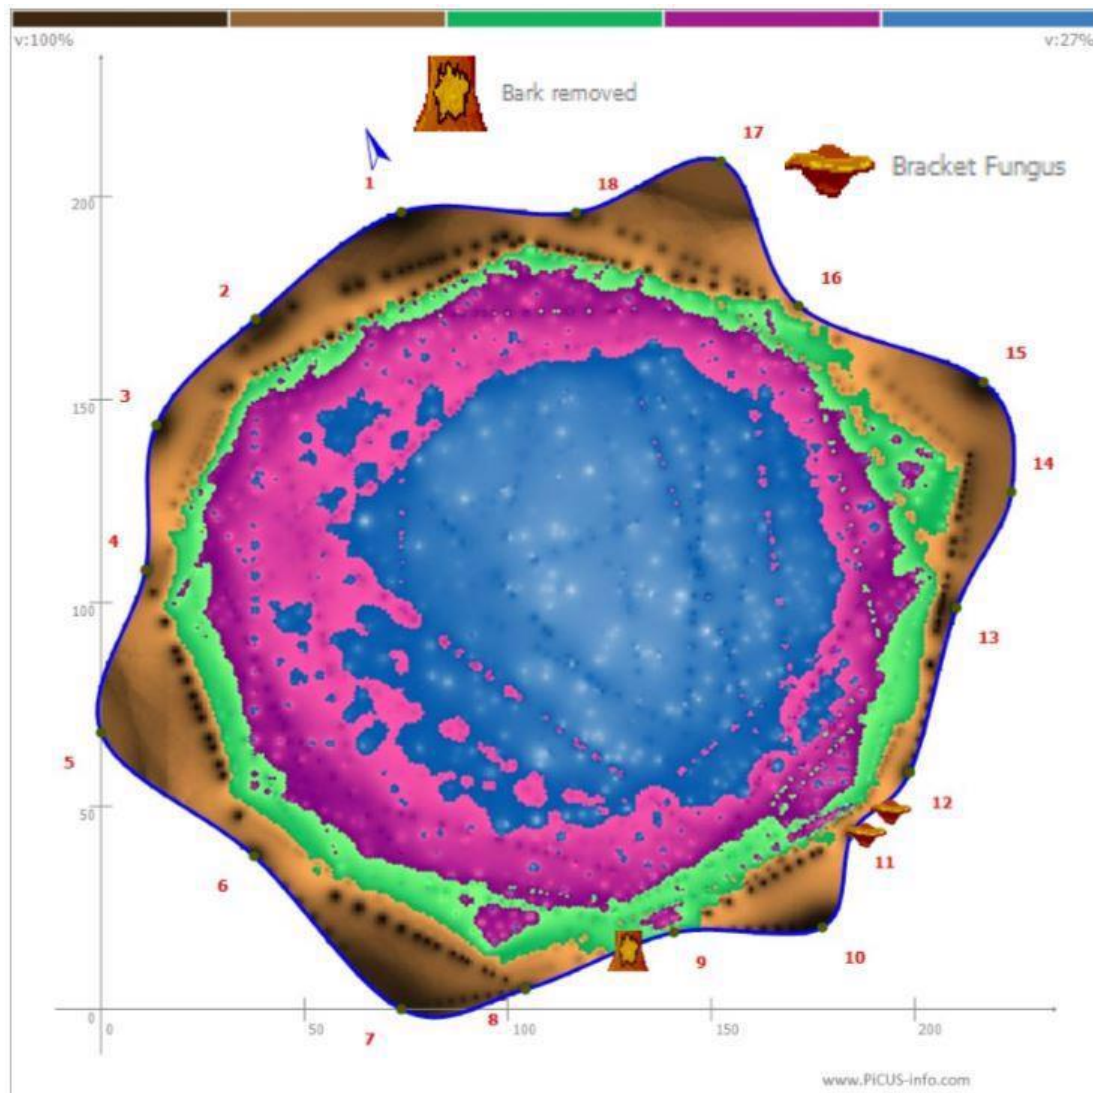
**The above tomogram shows extensive internal decay (blue, pink) which continues to develop across the stem (green, yellow/light brown) with some sound wood (dark brown) remaining around the circumference**

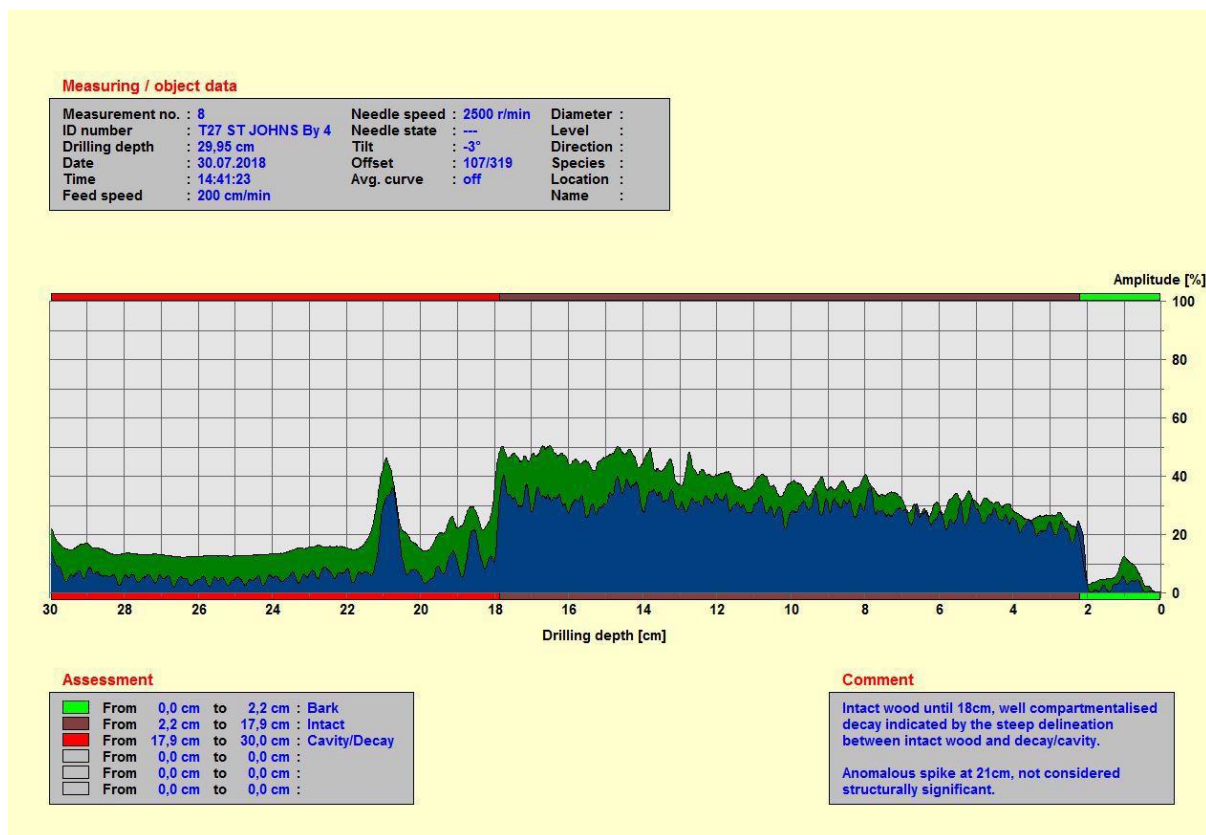
The above RESI PD trace (read from right to left) shows bark to 2cm, intact wood with high resistance until 18cm where resistance drops sharply, indicating well compartmentalised decay throughout the remainder of the trace
